# Leakage Analysis of 15CrMo Cladding Wall Pipe Used in 660MW Supercritical Unit

**Abstract:** The cause of leakage of the 15CrMo steel cladding wall tube of a 660MW supercritical unit of a power plant is analyzed by macro analysis, hardness measurement, and metallographic organization observation. The results show that the two sides of the weld are the original old pipe and the new pipe. The old pipe side, after the long-term operation and re-welding of the organization of the aging, is serious after analysis of the first leakage point is located in the old pipe fusion line; the first leakage point is located in the old pipe fusion line, the existence of multiple cracks in the inner wall of the pipe and the presence of oxide skin inside the cracks indicate that the cracks have existed for a long time, and at the same time, due to the severe aging of the old pipe organization, the ability to withstand external forces becomes weaker, which contributes to the expansion of the cracks in the process of operation, which leads to the leakage of the pipe. As a result, the wall cladding pipe was pulled apart after being subjected to external forces.

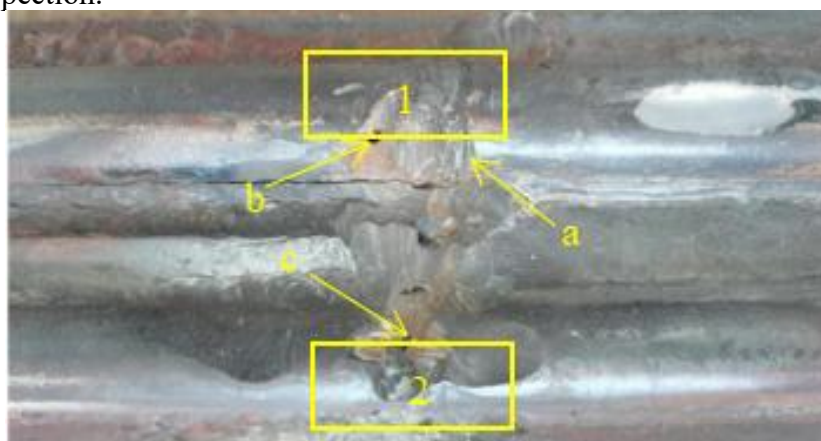
The macroscopic morphology of the package wall pipe on the left side of the horizontal flue sent for inspection is shown in Fig. 1. Since the package wall leakage pipe was leaked and replaced in 2018, the two sides of the weld are the original old pipe and the new pipe, respectively. There is a lateral leakage position of the leakage pipe, as shown in position a in the figure, after analyzing this is the initial leakage point, which is cracked along the fusion line of the old pipe side, and there are two other blowout leakage points, as shown in b and c in the figure respectively. Cut 1# and 2# specimens for inspection.

Fig. 1 Macro photo of wall-packed pipe and sampling location

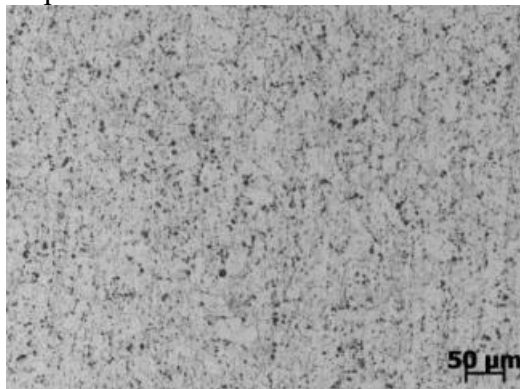
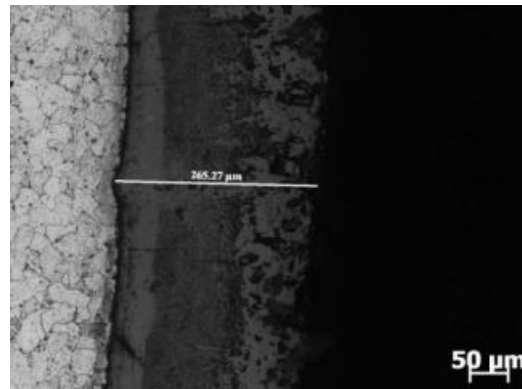
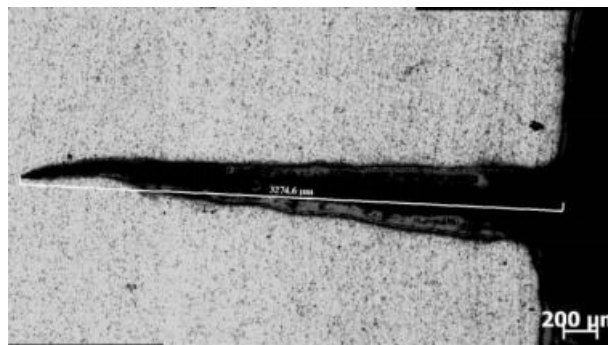
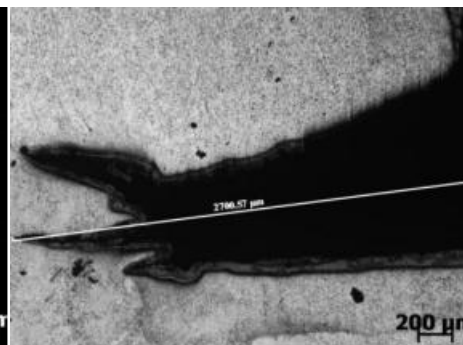
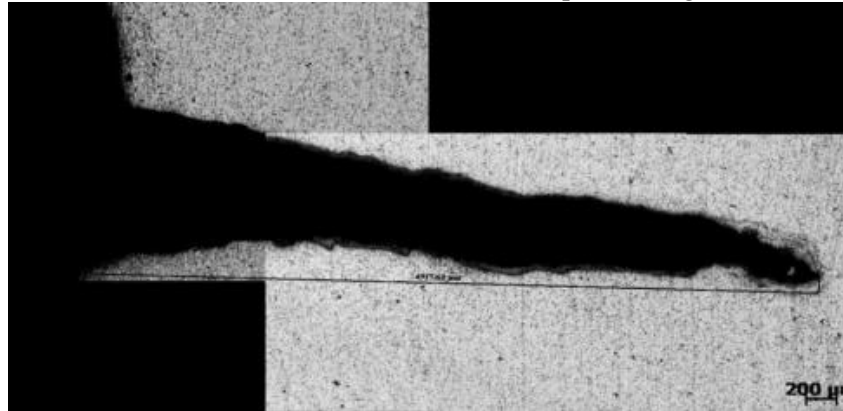
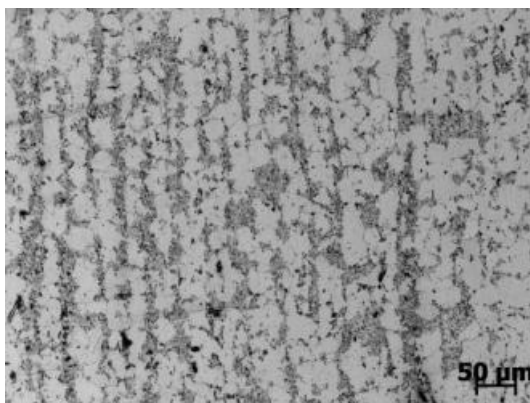
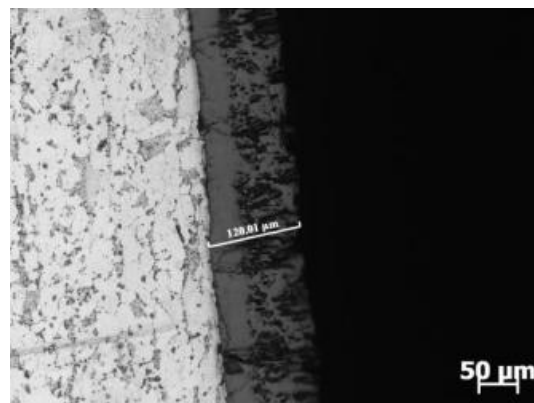
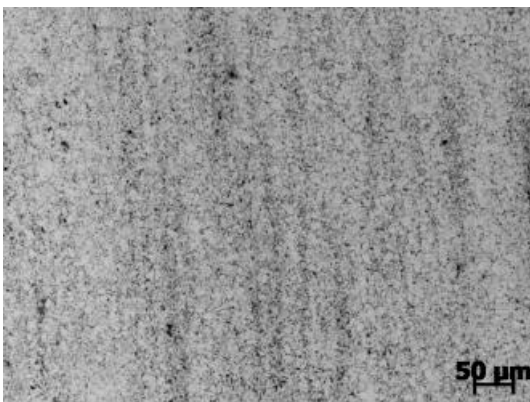
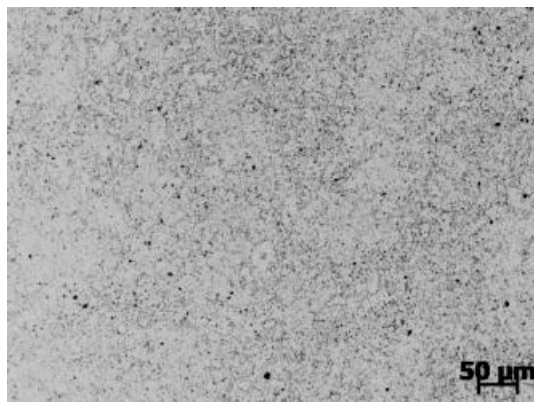
Fig. 2 Metallographic organization of 1# specimen burst side

After inspection, as shown in Figure 2, 1 # specimen burst side of the old pipe base material metallurgical organization for ferrite + carbide, spheroidization level of 4, the thickness of the inner wall of the oxide skin of 265.27  $\mu\text{m}$ , the existence of two cracks on the inner wall, one is located in the base material, the length of 3274.6  $\mu\text{m}$ , the other is located in the weld fusion line, the length of 2700.57  $\mu\text{m}$ , the existence of a small number of cracks in the inner skin of the oxide, the existence of the outer wall of a crack, located in the base material, length of 4917.62  $\mu\text{m}$ . One crack is located in the base material with a length of 4917.62  $\mu\text{m}$ , the metallurgical organization of the new pipe base material is ferrite+pearlitic+carbide, the spheroidization level is 2.5, and the thickness of the oxide skin on the inner wall is 120.01  $\mu\text{m}$ ; the metallurgical organization of the weld is ferrite+tempered bainite+carbide.

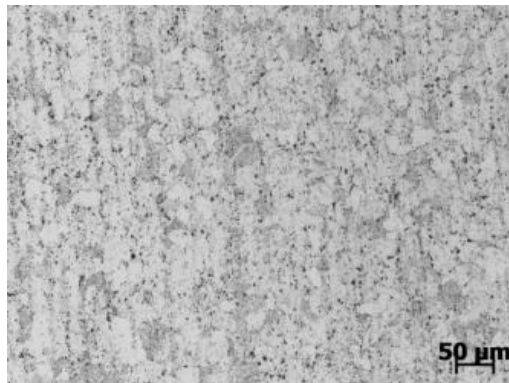
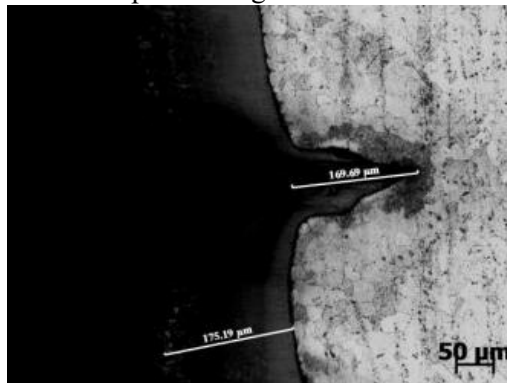
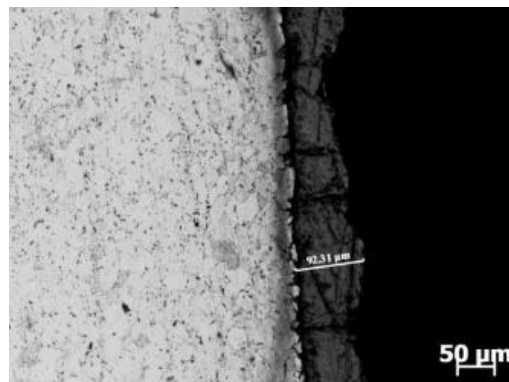
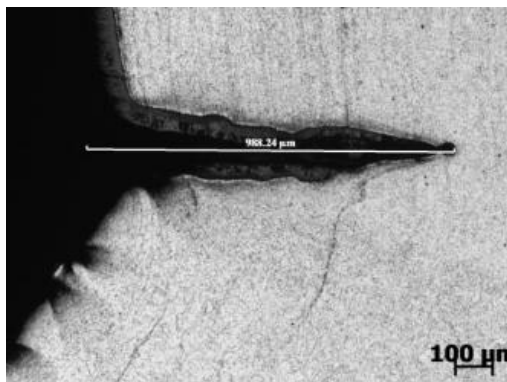
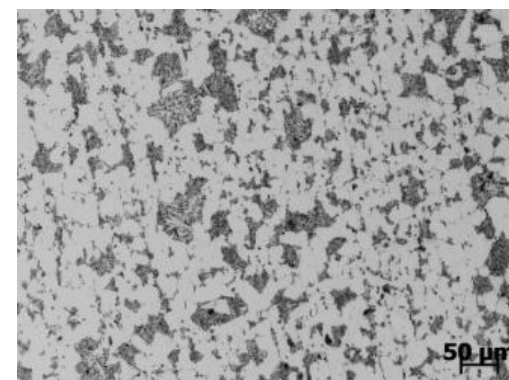
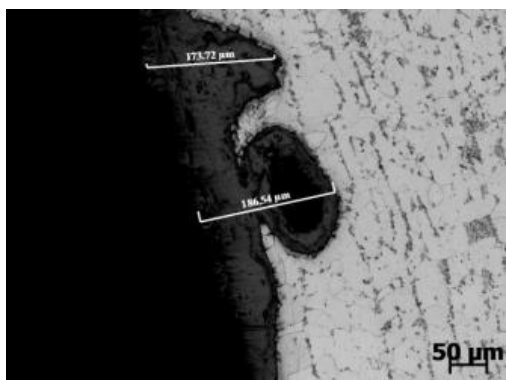
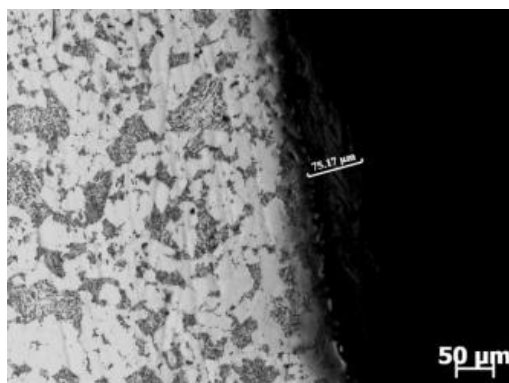
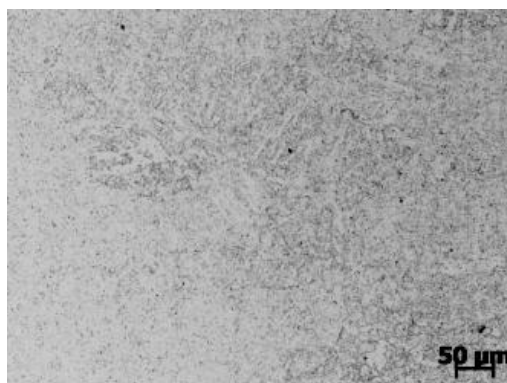
Fig. 3 Metallographic organization of 1# specimen on the opposite side of the bursting hole

As shown in Figure 3, 1 # specimen burst on the opposite side of the old pipe parent material metallurgical organization of ferrite + pearlite + carbide, spheroidization level of 3, the thickness of the inner wall of the oxide skin is 175.79  $\mu\text{m}$ , the thickness of the outer wall of the oxide skin of 92.31  $\mu\text{m}$ ; the presence of two cracks in the inner wall, the length of 988.24  $\mu\text{m}$ , 169.69  $\mu\text{m}$ , respectively, the cracks within the presence of the oxide skin. The metallographic organization of the new pipe parent material is ferrite + pearlite + a small amount of carbide, spheroidization level of 2.5, the thickness of the inner wall oxide skin is 173.72 $\mu\text{m}$ , 186.54 $\mu\text{m}$ , and the thickness of the outer wall oxide skin is 75.17 $\mu\text{m}$ ; the metallographic organization of the weld is ferrite + tempered bainite + carbide.

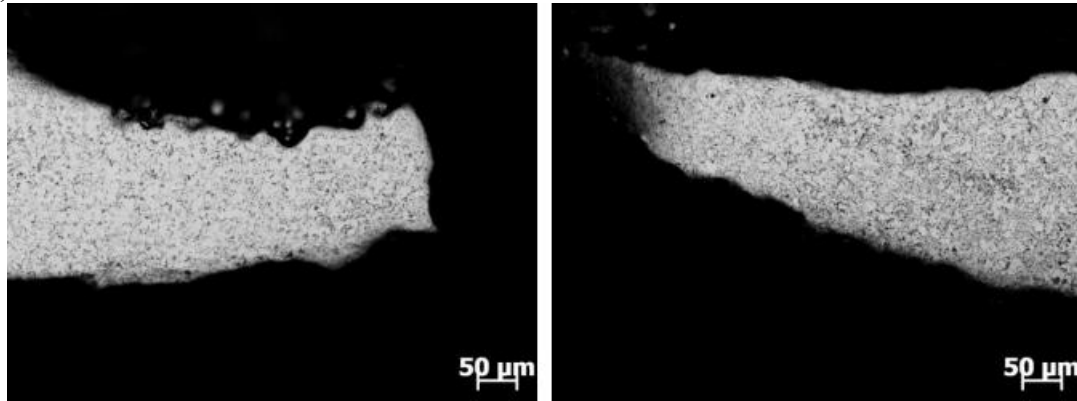
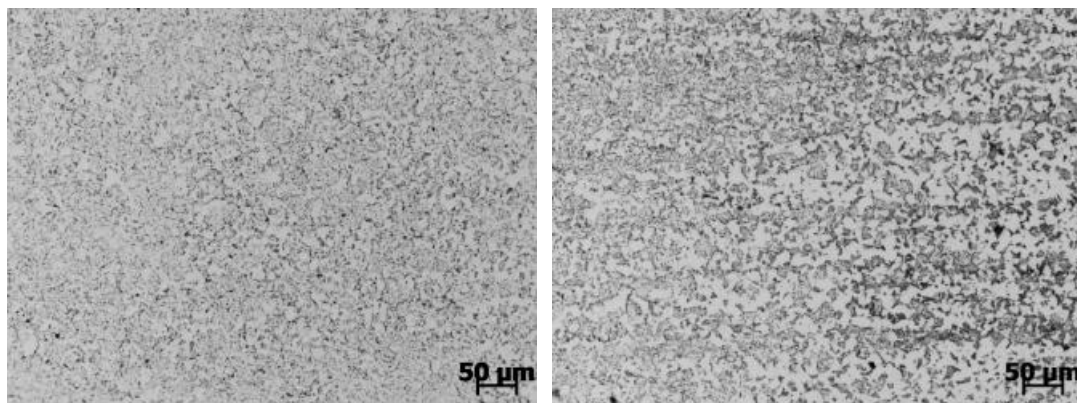
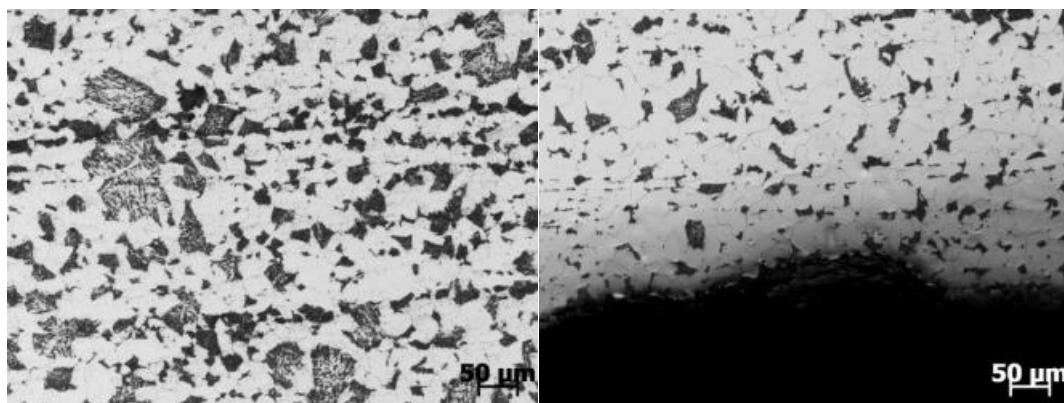
Fig. 4 Metallographic structure at blown position of sample 2#

As shown in Figure 4, 2 # specimen blowout location is located in the base material, the metallographic organization of ferrite + a small amount of pearlite + carbide, spheroidization level of 4, the weld metallographic organization of ferrite + tempered bainite + carbide, the heat affected zone organization is ferrite + tempered bainite. The normal position of both sides of the weld is consistent with the organization of the base material, the metallurgical organization is ferrite + pearlite, and there is no obvious oxide skin on the inner wall.

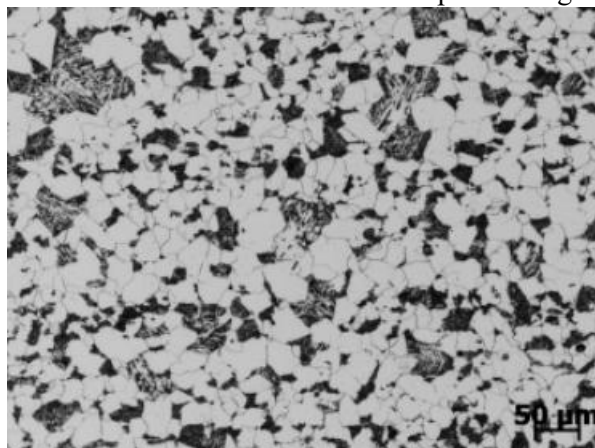
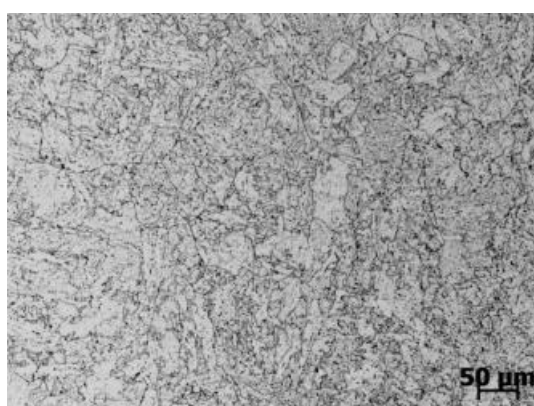
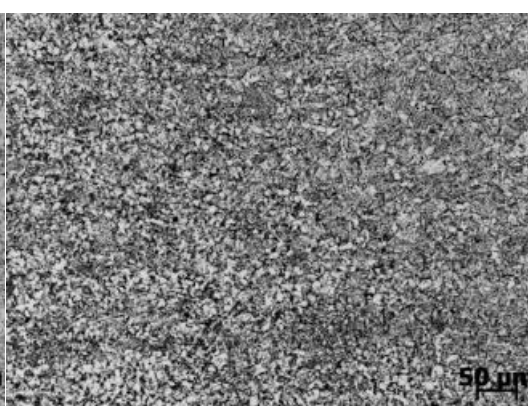
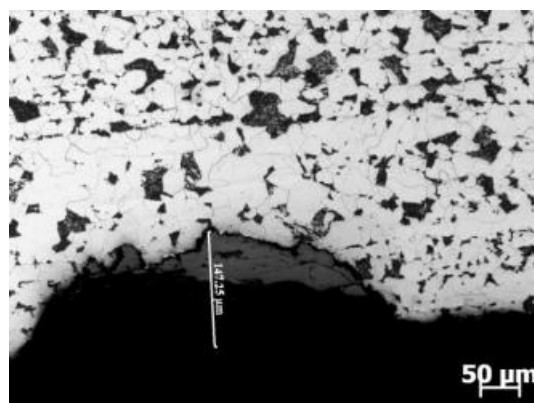
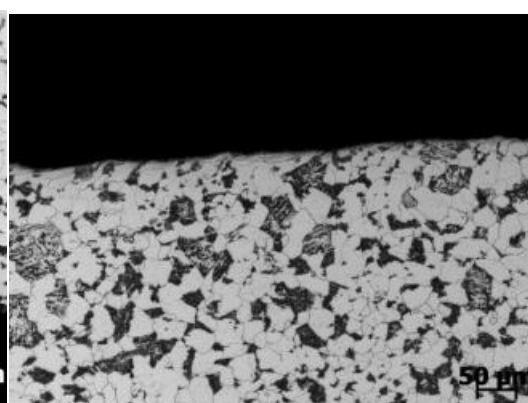
Fig. 5 Metallographic structure on the opposite of the blown position of sample 2#

As shown in Figure 5, 2 # specimen blowout location opposite side, weld both sides of the base material organization is consistent, the base material metallurgical organization are ferrite + pearlite, spheroidization level of 2.5, weld metallurgical organization for ferrite + tempered bainite, heat affected zone organization for ferrite + tempered bainite. The depth of oxidized skin on the inner wall is 147.25 μ m, and no obvious oxidized skin is seen on the outer wall.

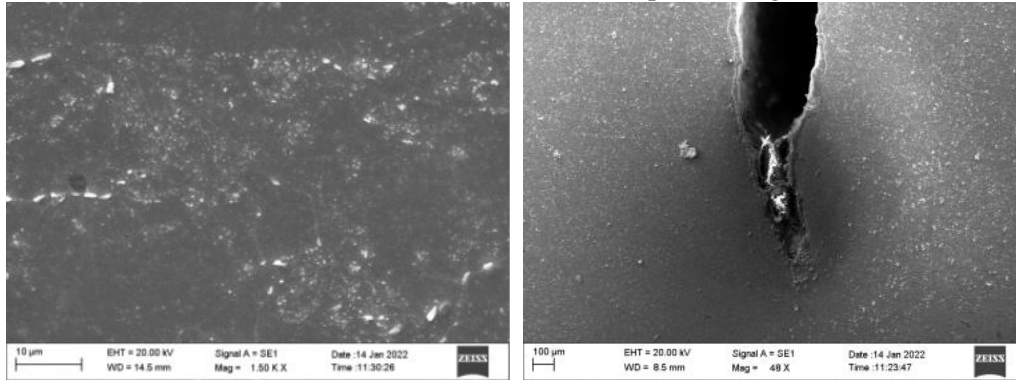
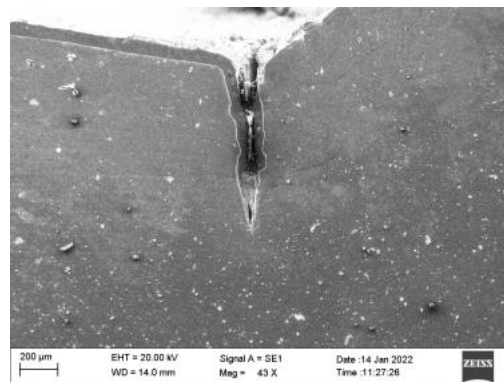
FIG. 6 SEM photos of 1# sample bursting crack and base metal

Using EVO-18 scanning electron microscope to analyze the 1# specimen, scanning electron microscope photos shown in Figure 6. From the scanning electron microscope crack photographs, it can be seen that there is an oxide skin inside the crack; from the specimen parent material scanning electron microscope photographs, it can be seen that the burst of the old tube side of the parent material metallurgical organization of ferrite + carbide, do not see the obvious pearlitic organization.
