# 2024 Bank Stability Assessment and Early Warning for Typical Riverbank Sections of the Jingjiang Reach (Hubei Section), Yangtze River

<sup>1</sup> Changjiang River Scientific Research Institute, Wuhan

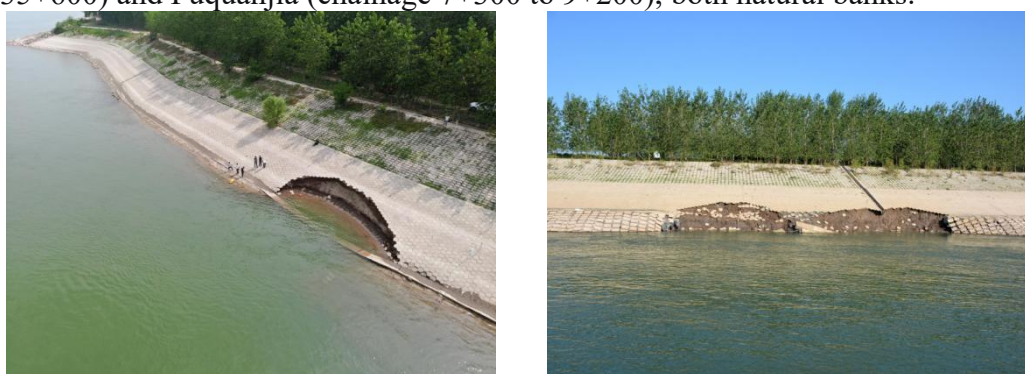
Figure 2.2-1 Field survey status of typical bank sections in the Jingjiang and Honghu reaches in October 2024

According to the field survey conducted in October 2024, the total length of bank collapse and affected areas within Jingzhou's jurisdiction in 2024 was approximately 53.35 km, accounting for 26.0% of the total shoreline length. The bank collapse sections mainly consisted of: 38.20 km of slight collapse (17.72 km of natural banks, 18.88 km of revetted banks including cracks), accounting for 71.6%; 11.73 km of moderate collapse (4.81 km of natural banks, 6.92 km of revetted banks), accounting for 22%; and severe collapse occurred at Changjiangcun (chainage 37+120 to 35+600) and Fuquanjia (chainage 7+300 to 9+200), both natural banks.

(a) Lower Beimenkou

(b) Sunliangzhou Section

This area mainly includes the Shishou Lianxinyuan section (1+600–0+000) and the Jianli Sunliangzhou section (7+400–6+000). The Lianxinyuan section is located on the upper part of the concave bank of the Tiaoguan bend. Affected by bank retreat in the upstream Beimenkou section, the near-bank riverbed has undergone significant scour and downcutting. Between 2022 and 2023, the average scour depth of the dry-season slope in the chainage range of 2+000–1+600 exceeded 3 m, causing the bank slope to steepen and develop subsidence cracks. The Sunliangzhou section is at the tail of Lower Jingjiang. Under the interaction of flow conditions from Dongting Lake and Lower Jingjiang, the near-bank riverbed exhibits interannual scour and intra-annual erosion-deposition alternation. The original riprap revetment has largely been lost. Between 2023 and 2024, the average scour depth at the front of the submerged toe in the chainage range of 7+400–6+000 reached 2.41 m, resulting in severe bank collapse.
