# Analysis of the Deformation Mechanism of the Top Slope at the Inlet of the Lijiaxia Hydropower Station Diversion Tunnel

**Abstract.** After long-term operation of Lijiaxia Hydropower Station in Qinghai Province after reservoir storage, the surface part of the slope body at the top of the inlet of the diversion tunnel shows signs of deformation and tension cracking, which is a serious threat to the operation safety of the hydropower station. In order to study the deformation mechanism of the slope and its evolution process, analyse the causes of slope deformation and assess the safety and stability of the slope, this paper adopts comprehensive investigation means such as drilling, testing and inspection, and carries out a detailed investigation and research on the geological and environmental characteristics of the slope such as topography, stratigraphy and lithology, geological structure, signs of deformation, geostress and hydrogeological conditions. Combined with the monitoring data of 9 monitoring points to carry out three-dimensional modeling, numerical simulation evolution analysis, and the use of limit equilibrium theory, strength reduction theory method to analyze and cal

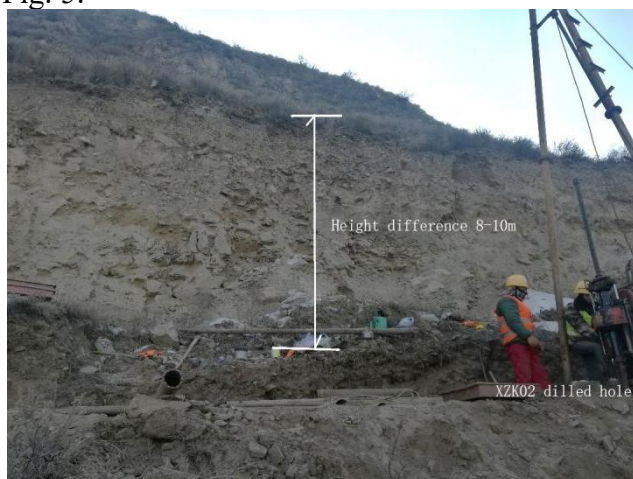
This investigation found that the tensile crack I & II found in the previous geological investigation have been unable to identify their tensile characteristics, due to the continuous deformation, tensile fracture and collapse of the deformation body for many years. I At the trailing edge of the deformed body (elevation between 2275m ~ 2300m), new tensile cracks appear, there are new pulling deformation, mainly increased III, IV, V, V-1 tensile cracks. Among them, the deformation and cracking of tensile crack III is the most obvious, and the vertical dislocation distance is 8 ~ 10 m; the tension crack IV is the trailing edge boundary of the current deformation body, and the vertical staggered distance is about 0.7 ~ 1.0 m. Its overall scale is smaller than that of tensile crack III, and its formation time is later than that of tensile crack III. As shown in Fig. 4 and Fig. 5.

Fig.4 Photograph of the current condition of tensile crack III

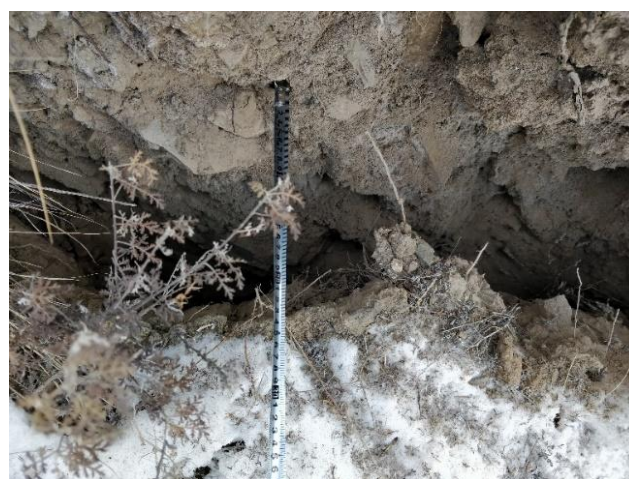
Fig.5 Photographs of the current condition of tension crack IV

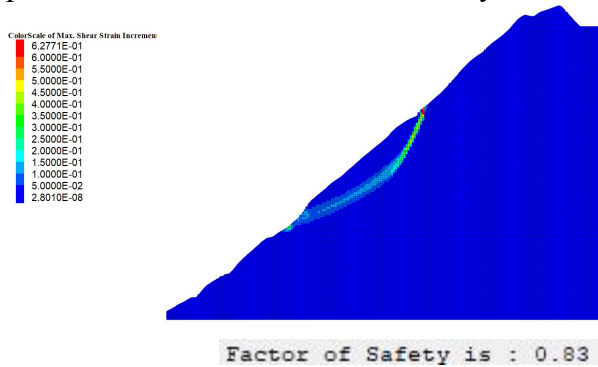
The corresponding maximum shear strain increment distribution is further extracted as shown in Fig. 12 and Fig. 13. As can be seen from the figures, the distribution of the maximum shear strain increment corresponding to the safety factor calculated by the strength reduction method is in the form of strips, and basically through the entire slope, from which it can be judged that the current slope is in an unstable state. The stability coefficient calculated by this method is relatively low.

Fig.12 Contour of maximum shear strain increment for natural condition

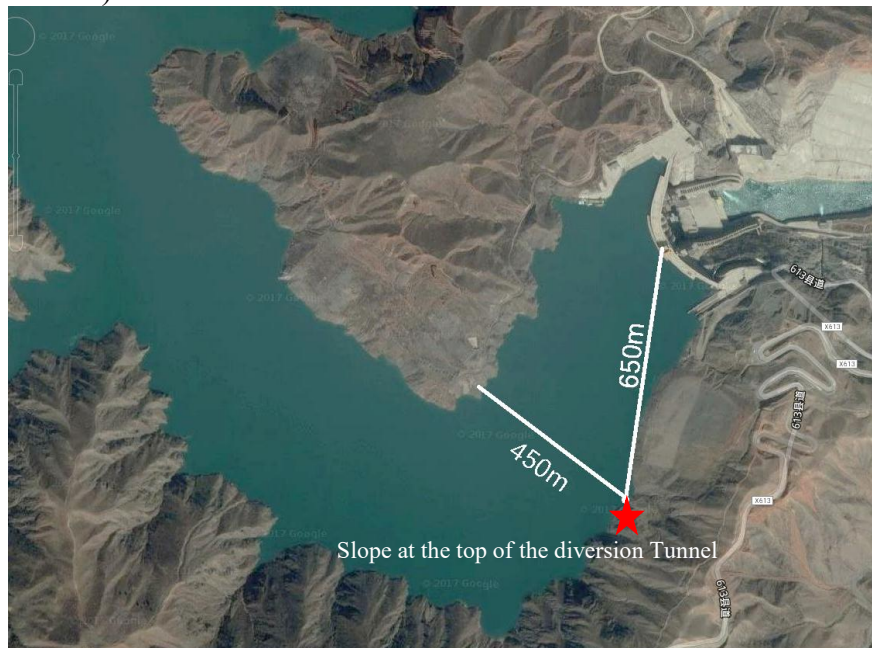
This calculation uses energy to calculate, and the calculation parameters are determined according to the recommended values of the parameters in Table 2. The distance between the high slope at the entrance of the diversion tunnel and the opposite bank is about 450 m, and the nearest

distance from the dam is about 650 m, as shown in Fig.14. According to the field investigation and calculation, the maximum volume of one-time instability sliding is determined to be 424,500 m<sup>3</sup> (above the water level ).

Fig.14 Relative position map of slope and dam
