# Monitoring Masonry Wall Performance Using Strain Gauge and Distributed Fiber Optical Sensor

**Abstract.** Current, a substantial number of masonry structures remain in existence, and it is of great significance to monitor their safety. This study employs quasi-static testing of masonry walls as the research objective to monitor masonry wall performance using both strain gauge and distributed fiber optical sensor (DFOS). This study revealed the failure patterns of masonry wall under the quasi-static condition. By comparing the results from single-point optical fiber strain measurement with those from strain gauge, the feasibility and precision of DFOS for strain monitoring in masonry structure were validated.

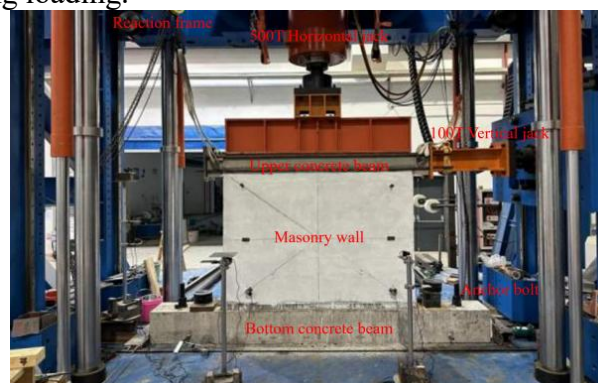
Test Setup

Figure 1. The unreinforced masonry wall and test setup

The test was conducted in the Structural Engineering Laboratory of Xi'an Jiao Tong-Liverpool University. The loading setup is shown in Fig. 1 b). The vertical load was applied using the 500T hydraulic jack through a horizontal loading beam, while the horizontal load was introduced via a steel reaction beam connected to a 100T servo-controlled actuator. The quasi-static cyclic loading protocol followed the Standard (JGJ 101—2015). Prior to testing, the specimen was securely anchored to the reaction floor using high-strength bolts, and the bottom beam was laterally restrained by hydraulic jacks to prevent sliding during loading.

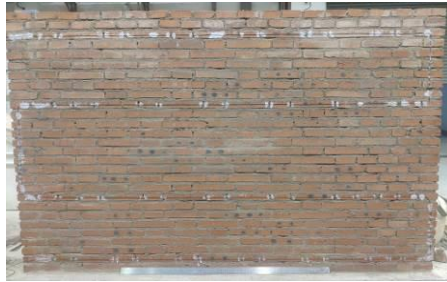
a) Photo of the optical fibre layout

Figure 2. The layout of strain gauges and optical fiber

Multiple strain monitoring techniques were employed in this study, with the instrumentation details summarised in Table 1. The layout of strain gauges and optical fiber was illustrated in Fig. 2.
